**Flood Control Project Maintenance
Levee Inspections**
LMA District Cover Sheet
Spring 2017 Levee Inspection Results

Reclamation District No. 2031 Elliot

Spring 2017 Levee Inspection Results

Waterway			Bank	Unit Miles
Unit No. 01 Stanislaus River			Left	7.07
	Spring (March - May)	Summer (June - August)	(September - November) Fall	Winter (December - February)
Unit Maintenance Rating (Fall Only)				
Date of Inspection	4/25/2017 - 4/25/2017			
DWR Inspector	Maksim Khashchuk			
Accompanied By	Arvid Carlson RD2031

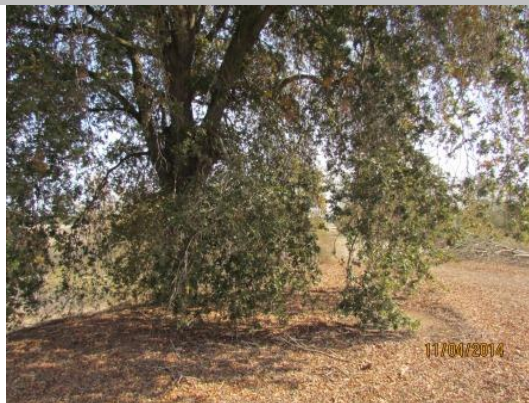
Photo 1 of 1 : SP_2017_RD2031_308_25_20170407_00007.jpg

LM Start	2.01	Rating **	M	Issue No.	25
LM End	2.01	Issue Type +	Ma	Location *	LS
Category	Earthen Levee			GPS Latitude/Longitude	
				Start	End
Item	Trim / Thin Trees			37.640874 °	37.640874 °
				-121.223870 °	-121.223870 °
DWR ID	DWR_RD2031_02_f_2014_25				
Comment Code					
T1 : Trim trees to at least five feet above ground level.					
Inspector Comment

View of the overgrown tree obstructing visibility and access of the landside levee slope.

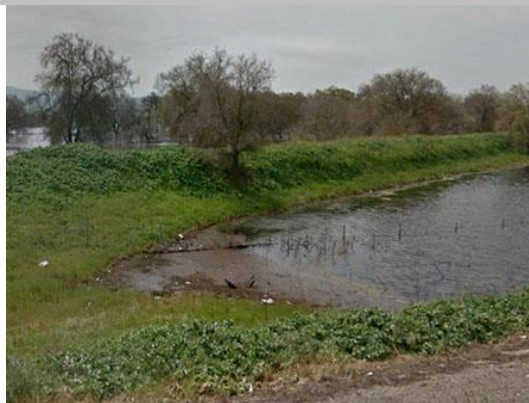
Photo 1 of 1 : SP_2017_RD2031_308_30_20170518_00054.jpg

LM Start	2.14	Rating **	U	Issue No.	30
LM End	2.34	Issue Type +	Ma	Location *	LS
Category	Earthen Levee			GPS Latitude/Longitude	
				Start	End
Item	Vegetation			37.640632 °	37.640217 °
				-121.221539 °	-121.217870 °
DWR ID	DWR_RD2031_02_s_2017_30				
Comment Code					
V2 : Remove the wild growth other than native grasses from the levee slopes.					
Inspector Comment					
The landside slope is unmaintained and has excessive vegetation that is obstructing visibility and access.

View of the dense vegetation on the landside levee slope.

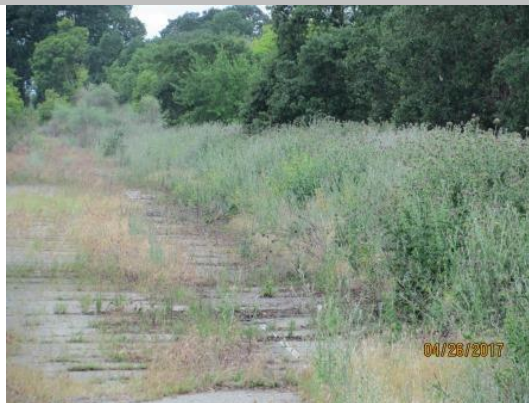
Photo 1 of 2 : SP_2017_RD2031_308_21_20170427_00051.jpg

LM Start	2.14	Rating **	M	Issue No.	21
LM End	2.34	Issue Type +	Ma	Location *	CR
Category	Earthen Levee			GPS Latitude/Longitude	
				Start	End
Item	Vegetation			37.640632 °	37.640217 °
				-121.221539 °	-121.217874 °
DWR ID	DWR_RD2031_02_f_2014_21				
Comment Code					
V2 : Remove the wild growth other than native grasses from the levee slopes.					
Inspector Comment

View of overgrown vegetation on the levee crown.

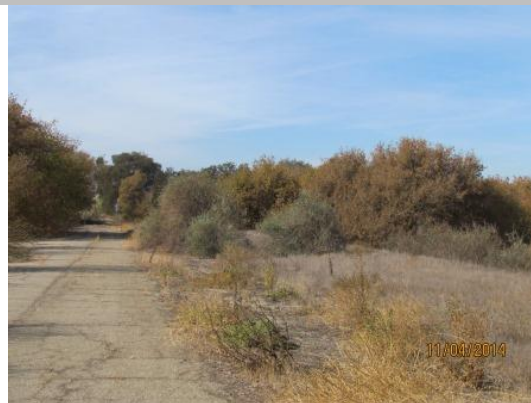
Photo 2 of 2 : SP_2017_RD2031_308_21_20170407_00006.jpg

Another view of overgrown vegetation on the levee crown.

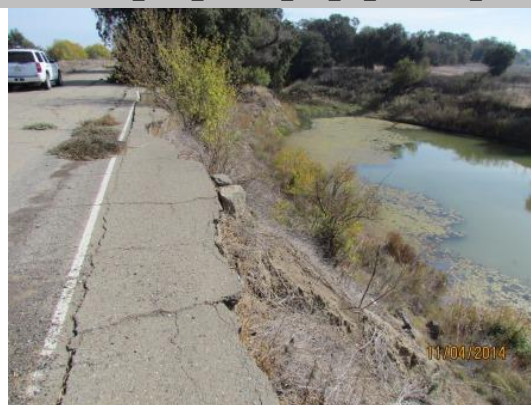
Photo 1 of 1 : SP_2017_RD2031_308_26_20170407_00008.jpg

LM Start	2.27	Rating **	U	Issue No.	26
LM End	2.28	Issue Type +	Ob	Location *	WS
Category	Earthen Levee			GPS Latitude/Longitude	
				Start	End
Item	Erosion / Bank Caving			37.640371 °	37.640340 °
				-121.219254 °	-121.218974 °
DWR ID	DWR_RD2031_02_f_2014_26				
Comment Code					
E1 : Note and monitor erosion site.					
Inspector Comment

View of the caving bank on the waterside facing upstream.

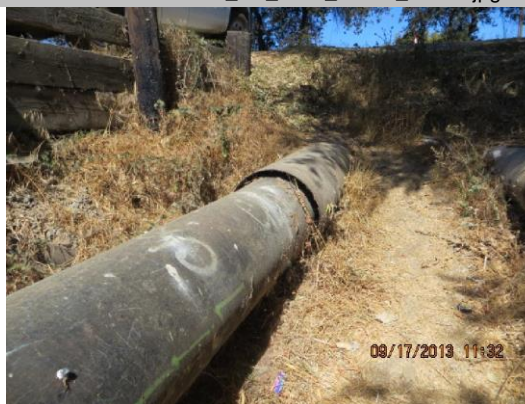
Photo 1 of 3 : UCIP_SP_2017_20719_34860.jpg

LM Start	3.21	Rating **	M	Issue No.	971
LM End	3.21	Issue Type +	En	Location *	LS
Category	Supplemental			GPS Latitude/Longitude	
				Start	End
Item	DWR UCIP Field Study			37.638185 °	37.638185 °
				-121.202906 °	-121.202906 °
DWR ID					
Comment Code					
Inspector Comment					
FS_ID:20719 DS_ID:20492 EP_NO: N/A Repair Type: Non-Urgent Crossing Status: Found UCIP Comments: Annular space between 20-inch and 24-inch pipe not grouted. FIELD_STRUCT_DESC: 24-inch steel pipe through levee 8.0 feet below crown. Pump on pile structure in river. 20-inch steel pipe sleeved through 24-inch. 4'X11' concrete distribution box on LS toe. 2-inch electrical conduit at same location. Originally included in the 1968 O&M manual. FS Date: 9/17/2013

24-inch with 20-inch sleeved through it.

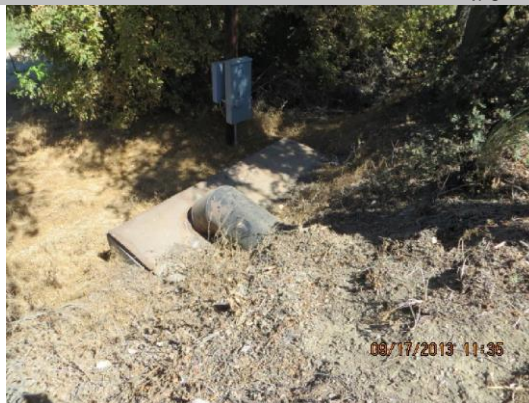
Photo 2 of 3 : UCIP_SP_2017_20719_34859.jpg

LM Start	3.21	Rating **	M	Issue No.	971 (cont)	
LM End	3.21	Issue Type +	En	Location *	LS	
Category	Supplemental			GPS Latitude/Longitude		
				Start		End
Item	DWR UCIP Field Study			37.638185 °		37.638185 °
				-121.202906 °		-121.202906 °
DWR ID						
Comment Code						
Inspector Comment						
FS_ID:20719 DS_ID:20492 EP_NO: N/A Repair Type: Non-Urgent Crossing Status: Found UCIP Comments: Annular space between 20-inch and 24-inch pipe not grouted. FIELD_STRUCT_DESC: 24-inch steel pipe through levee 8.0 feet below crown. Pump on pile structure in river. 20-inch steel pipe sleeved through 24-inch. 4'X11' concrete distribution box on LS toe. 2-inch electrical conduit at same location. Originally included in the 1968 O&M manual. FS Date: 9/17/2013

Concrete distribution box on LS slope.

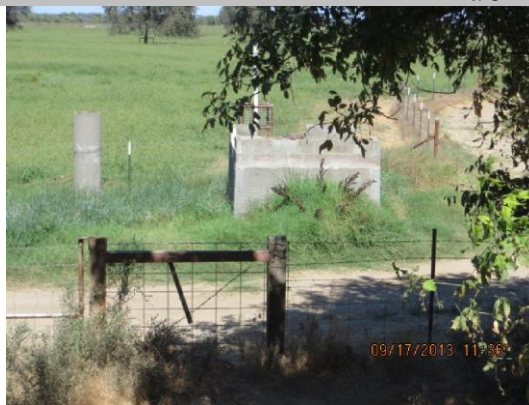
Photo 3 of 3 : UCIP_SP_2017_20719_34858.jpg

Concrete distribution box off LS toe.

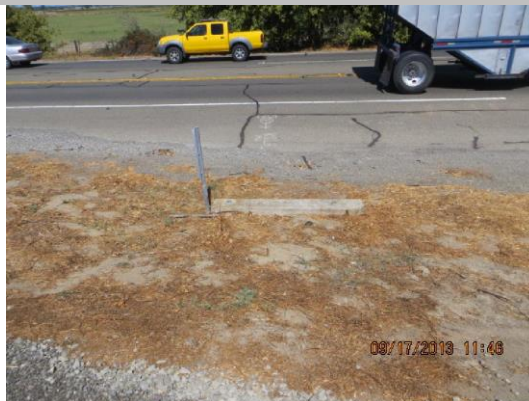
Photo 2 of 3 : UCIP_SP_2017_20723_34881.jpg

Concrete headwall on LS toe.

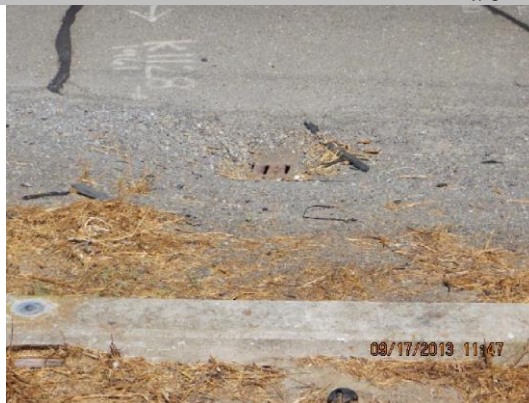
Photo 3 of 3 : UCIP_SP_2017_20723_34880.jpg

LM Start	3.76	Rating **	A/W	Issue No.	972 (cont)	
LM End	3.76	Issue Type +	Ma	Location *	LS	
Category	Supplemental			GPS Latitude/Longitude		
				Start	End	
Item	DWR UCIP LMA Responsibility			37.638063 °	37.638063 °	
				-121.192917 °	-121.192917 °	
DWR ID						
Comment Code						
Inspector Comment						
FS_ID:20723 DS_ID:20507 EP_NO: N/A Repair Type: No Action Needed Crossing Status: Found UCIP Comments: FIELD_STRUCT_DESC: 5'x5' concrete box culvert semi-through levee 11.0 feet below crown. 30-inch pipe runs through culvert. Drop inlet next to concrete headwall on LS toe. Originally included in the 1968 O&M manual. FS Date: 9/17/2013

Drop inlet on LS toe.

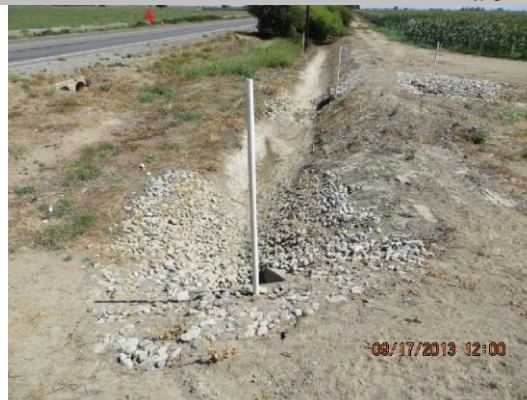
Photo 1 of 3 : UCIP_SP_2017_51374_34886.jpg

Comment Code					
Inspector Comment					
FS_ID:51374					
DS_ID:20496					
EP_NO: N/A					
Repair Type: No Action Needed					
Crossing Status: Found					
UCIP Comments: 11/16/2016 Crossing has been downgraded from					
Urgent to No Action Needed debris has been cleared from both WS and					
LS. (O. Magana - DWR UCIP)09/17/2013 Minor debris blocking					
closure of flapgate on WS toe. (W. Wylie - DWR UCIP)					
FIELD_STRUCT_DESC: 24-inch corrugated metal pipe through levee

11.0 feet below crown. Concrete "U" headwall on each end. Flap gate					
on the waterward end. Originally included in the 1968 O&M manual.					
[Additional Reference(s): DWR Levee Log, 2005. USACE San Joaquin					
River O&M Unit 4, June 1968, (HLM 3.88), Drawing No. 07-04-1666,					
sheets 1666/23 and 1666/53, Station 2+38S.T].					
FS Date: 11/16/2016

Concrete headwall on LS toe.

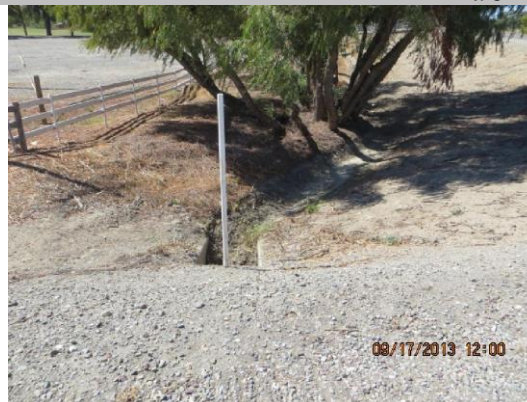
Photo 2 of 3 : UCIP_SP_2017_51374_34885.jpg

Concrete headwall on WS toe.

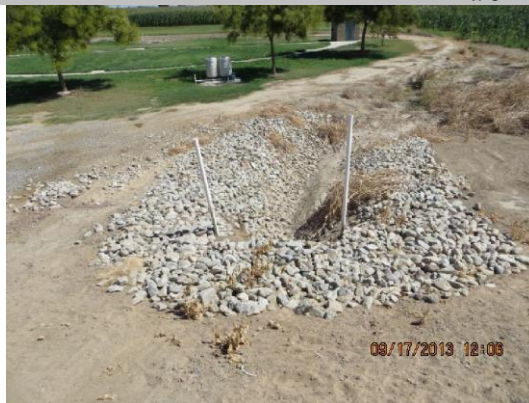
Photo 1 of 3 : UCIP_SP_2017_20728_34895.jpg

LM Start	4.16	Rating **	A/W	Issue No.	975
LM End	4.16	Issue Type +	Ma	Location *	LS
Category	Supplemental			GPS Latitude/Longitude	
				Start	End
Item	DWR UCIP LMA Responsibility			37.633376 °	37.633376 °
				-121.190765 °	-121.190765 °
DWR ID					
Comment Code					
Inspector Comment					
FS_ID:20728 DS_ID:20497 EP_NO: N/A Repair Type: No Action Needed Crossing Status: Found UCIP Comments: FIELD_STRUCT_DESC: 24-inch corrugated metal pipe through levee 9.6 feet below crown. Concrete "U" headwall on each end. Flap gate on the waterward end. Flashboards in slots on the landward headwall. Originally included in the 1968 O&M manual. FS Date: 9/17/2013

Concrete headwall at ditch on LS toe.

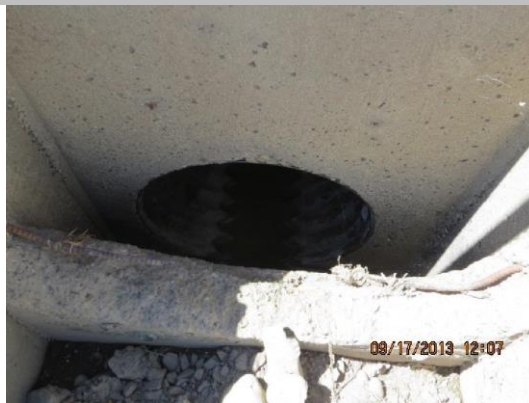
Photo 2 of 3 : UCIP_SP_2017_20728_34894.jpg

Concrete headwall on LS toe.

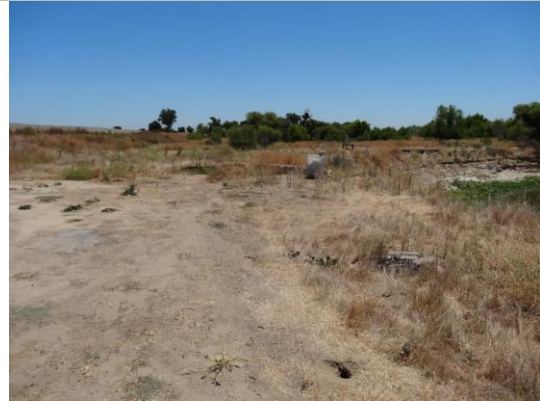
Photo 1 of 3 : SP_2017_RD2031_308_1_20170407_00001.jpg

Comment Code					
Inspector Comment					
07/08/2016: The erosion in the berm was found further progressed toward levee toe.					
08/19/2015: No significant change observed.					
07/17/2014: The erosion has slightly expanded toward levee toe at two pocket locations.					
09/10/2013: The site has been visited. The erosion has expanded toward levee crest at two pocket locations.					
07/18/2012: No significant change observed on the site.					
08/18/2011: No significant change observed on the site. Dead trees and animal activities are visible. The closest point of the erosion site to the levee toe is about 100 ft.					
10/19/2010: There is active scouring occurring on the bank due to the nature of the flow and the lack of armor protection. There is also a fallen log immediately downstream of where the erosion has occurred and is protruding outward, possibly creating an eddy and scouring the bank. With the remaining 100-foot wide berm, the levee prism is not yet affected. However, the bank will continue to degrade, and eventually intrude into the levee prism if no protection is put in place. Erosion site is recommended for annual assessment and monitoring during flood events. [2016 Site ID:RD2031U02RM78.7]

Looking downstream of the erosion site.

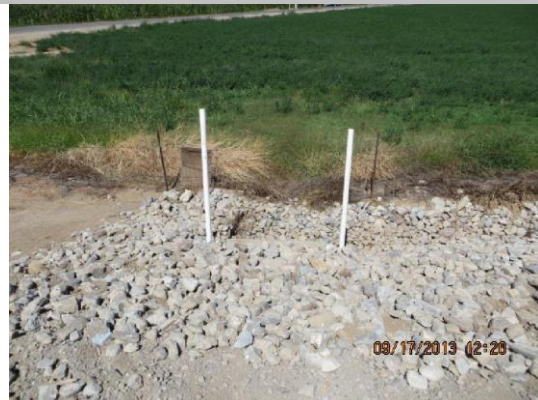
Photo 1 of 3 : UCIP_SP_2017_22872_39036.jpg

LM Start	4.70	Rating **	M	Issue No.	976
LM End	4.70	Issue Type +	En	Location *	WS
Category	Supplemental			GPS Latitude/Longitude	
				Start	End
Item	DWR UCIP Field Study			37.630815 °	37.630815 °
				-121.182416 °	-121.182416 °
DWR ID					
Comment Code					
Inspector Comment					
FS_ID:22872 DS_ID:24676 EP_NO: N/A Repair Type: Non-Urgent Crossing Status: Found UCIP Comments: No permit identified for this crossing. FIELD_STRUCT_DESC: 16-inch PVC irrigation pipe through the levee 6-feet below the crown. Headwall on LS toe. FS Date: 9/17/2013

Concrete headwall at outlet on LS toe.

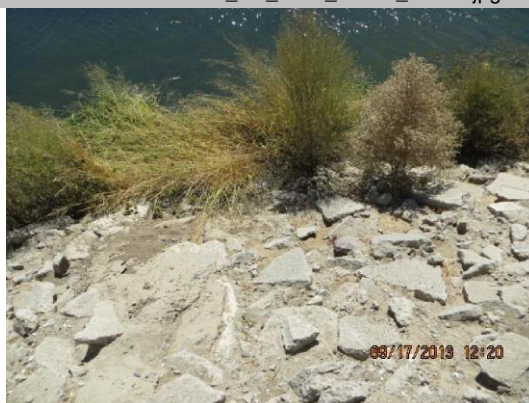
Photo 2 of 3 : UCIP_SP_2017_22872_39035.jpg

LM Start	4.70	Rating **	M	Issue No.	976 (cont)	
LM End	4.70	Issue Type +	En	Location *	WS	
Category	Supplemental			GPS Latitude/Longitude		
				Start		End
Item	DWR UCIP Field Study			37.630815 °		37.630815 °
				-121.182416 °		-121.182416 °
DWR ID						
Comment Code						
Inspector Comment						
FS_ID:22872						
DS_ID:24676						
EP_NO: N/A						
Repair Type: Non-Urgent						
Crossing Status: Found						
UCIP Comments: No permit identified for this crossing.						
FIELD_STRUCT_DESC: 16-inch PVC irrigation pipe through the levee						
6-feet below the crown. Headwall on LS toe.						
FS Date: 9/17/2013

Concrete debris placed over pipe location on WS shoulder.

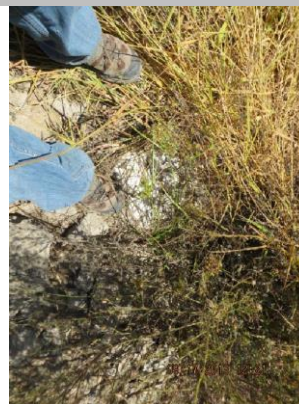
Photo 3 of 3 : UCIP_SP_2017_22872_39034.jpg

PVC pipe partially visible on WS toe.

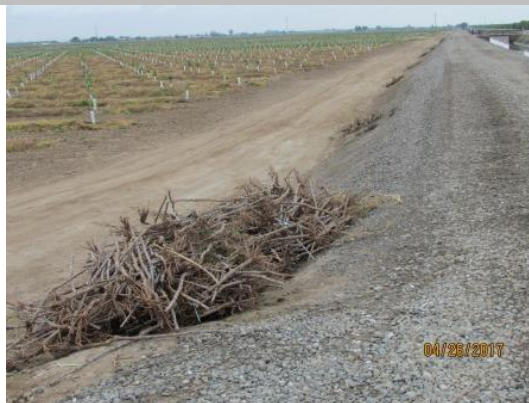
Photo 1 of 1 : SP_2017_RD2031_308_29_20170427_00053.jpg

LM Start	4.88	Rating **	M	Issue No.	29
LM End	4.88	Issue Type +	Ma	Location *	LS
Category	Earthen Levee			GPS Latitude/Longitude	
				Start	End
Item	Encroachments			37.630827 °	37.630827 °
				-121.179072 °	-121.179072 °
DWR ID	DWR_RD2031_02_s_2017_29				
Comment Code					
PR : Prunings					
Inspector Comment

View of the pruning pile on the levee slope.

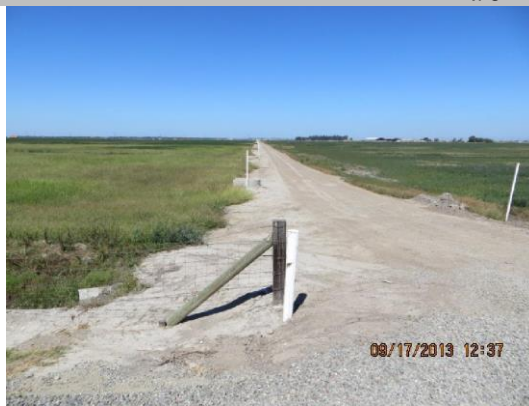
Photo 1 of 2 : UCIP_SP_2017_22873_39038.jpg

LM Start	5.63	Rating **	M	Issue No.	977
LM End	5.63	Issue Type +	En	Location *	LS
Category	Supplemental			GPS Latitude/Longitude	
				Start	End
Item	DWR UCIP Field Study			37.630779 °	37.630779 °
				-121.165402 °	-121.165402 °
DWR ID					
Comment Code					
Inspector Comment					
FS_ID:22873 DS_ID:24677 EP_NO: N/A Repair Type: Non-Urgent Crossing Status: Found UCIP Comments: No permit identified for this crossing. FIELD_STRUCT_DESC: 24-inch PVC irrigation pipeline through levee 5.0-feet below crown. Slide gate at waterward shoulder. 6-inch steel riser on WS shoulder. FS Date: 9/17/2013

Concrete turnouts visible off LS toe along road.

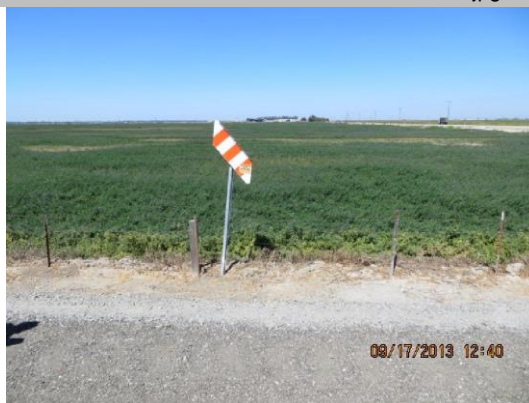
Photo 1 of 2 : UCIP_SP_2017_20745_34961.jpg

LM Start	5.93	Rating **	M	Issue No.	978
LM End	5.93	Issue Type +	En	Location *	LS
Category	Supplemental			GPS Latitude/Longitude	
				Start	End
Item	DWR UCIP Field Study			37.630760 °	37.630760 °
				-121.159951 °	-121.159951 °
DWR ID					
Comment Code					
Inspector Comment					
FS_ID:20745					
DS_ID:20503					
EP_NO: N/A					
Repair Type: Non-Urgent					
Crossing Status: Found					
UCIP Comments: Gasline may not have enough cover.					
FIELD_STRUCT_DESC: 8-inch gas line through the levee 1.0-foot below the crown. Originally included in the 1968 O&M manual. Sign on LS toe, pipe visible at canal.					
FS Date: 9/17/2013

Gasline marker on LS toe.

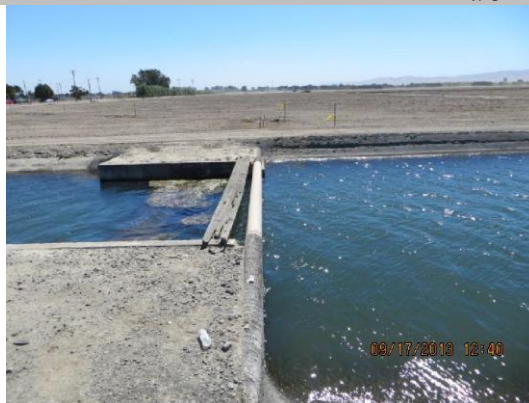
Photo 2 of 2 : UCIP_SP_2017_20745_34960.jpg

LM Start	5.93	Rating **	M	Issue No.	978 (cont)
LM End	5.93	Issue Type +	En	Location *	LS
Category	Supplemental			GPS Latitude/Longitude	
				Start	End
Item	DWR UCIP Field Study			37.630760 °	37.630760 °
				-121.159951 °	-121.159951 °
DWR ID					
Comment Code					
Inspector Comment					
FS_ID:20745 DS_ID:20503 EP_NO: N/A Repair Type: Non-Urgent Crossing Status: Found UCIP Comments: Gasline may not have enough cover. FIELD_STRUCT_DESC: 8-inch gas line through the levee 1.0-foot below the crown. Originally included in the 1968 O&M manual. Sign on LS toe, pipe visible at canal. FS Date: 9/17/2013

Gasline visible at crossing.
